## Return to Nominal EVA – Background

## Return to Nominal EVA – Residual Risk

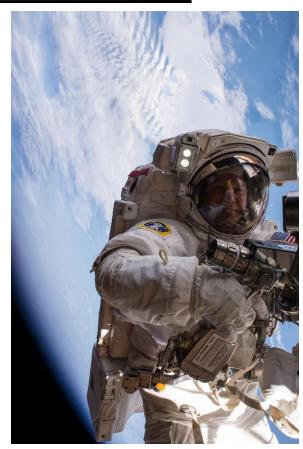
- During US EVA 35 in January 2016, one of the spacesuits allowed enough water to enter the helmet that the EVA was terminated
  - It is impossible to determine how much water was put into the helmet, but estimates range from 65cc to almost 500cc
  - A Problem Resolution Team (PRT) was convened, and that team's investigation concluded following ground testing of the hardware
  - Probable failure scenario: High latent loads and cold EVA conditions may have created high levels of condensate which may have overwhelmed the sublimator (which already had blocked supplemental slurper holes), and high metabolic rates may have driven additional moisture off the METOX further adding to the load on the system

Tim Kopra in SEMU 3011 during US EVA 35
